Life Extension of Ageing FPSO and SPM Calm Buoy Hulls and Deck Plates Under Corrosion Effects - Part 1B

Citation: Ebunuoha C., Saturday E.G., and Ebieto C.E. (2025) Life Extension of Ageing FPSO and SPM Calm Buoy Hulls and Deck Plates Under Corrosion Effects - Part 1B, *European Journal of Mechanical Engineering Research*, 12(1),90-120

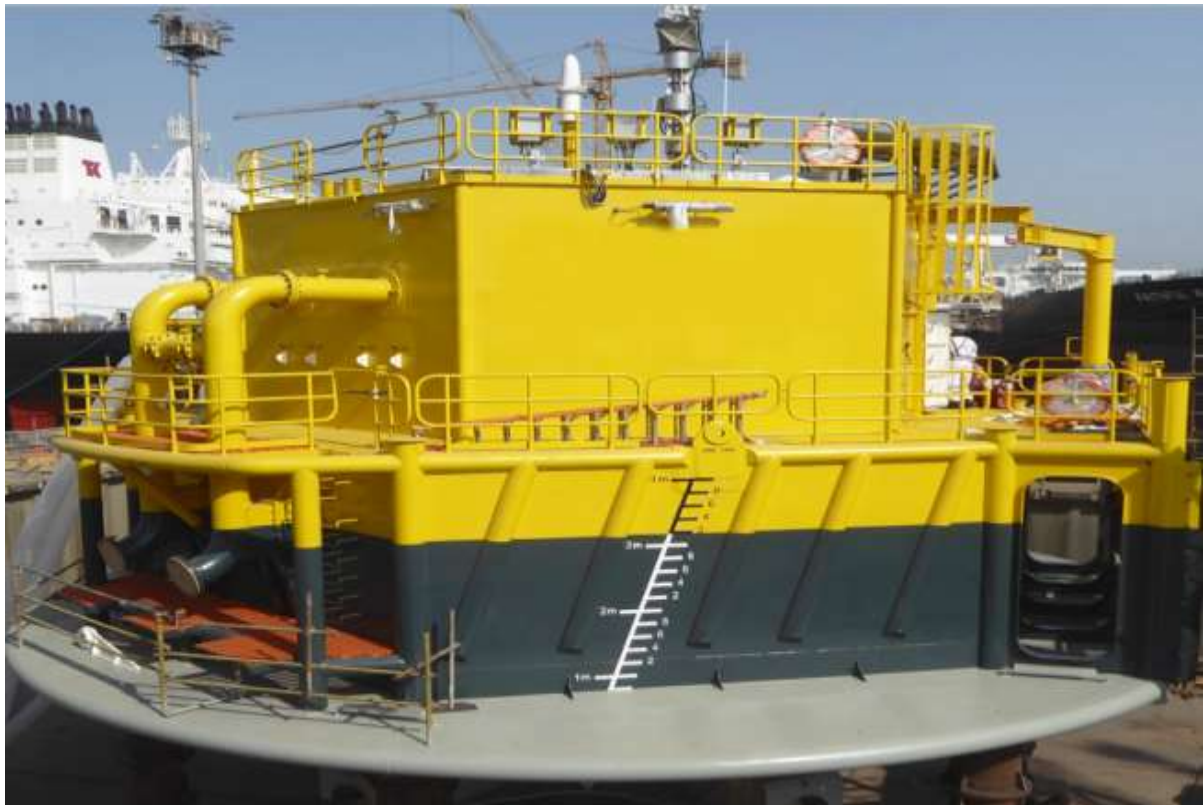
Figure (6): A turret type SPM calm buoy.

The implications and consequence of corrosion action is a global concern. The menace of corrosion wastages tends to jeopardize safety, retard technological advancement and ultimately lead to loss of production opportunities. Corrosion degradation reduces the useful service life of floating facilities such as FPSO and SPM calm buoy. The corrosion cost incurred from manufacturers of plates also passes cost onto the operators of floating facilities when the right corrosion margin is not kept to. The menace of corrosion is experienced by the FPSO and SPM calm buoy hulls and deck plates. The SPM calm buoy is built in compartments for the seawater ballast tanks such that each compartment is made up of top plate, mid upper plate, mid lower plate, bottom plate and floor plate. The FPSO ballast tanks is also compartmentalised. Notably, by class society standards, pitting depth up to 15 percent plate thickness is recommended for epoxy coating repairs to stop pit growth. For scattered pitting depth up to 33 percent plate with small diameter with low pit density less than 20 percent area is recommended for belzona epoxy paint putty and coat. On the other hand, deep pits greater than 33 percent thickness, that is smaller diameter pits less than 300mm is recommended for repair by weld infill and coating. Also, for average remaining thickness for pitted area greater than 50 percent as-built plate thickness, composite cold work repairs or crop and renew is recommended. Similarly, for remaining thickness less than or greater than 33 percent of as-built, such as large diameter pits or high pit density, crop and renew mitigation strategy is recommended. Finally, for insufficient remaining plate thickness less than 6 mm, crop and renew mitigation is recommended. Figure (6) represents a turret type SPM calm buoy view.

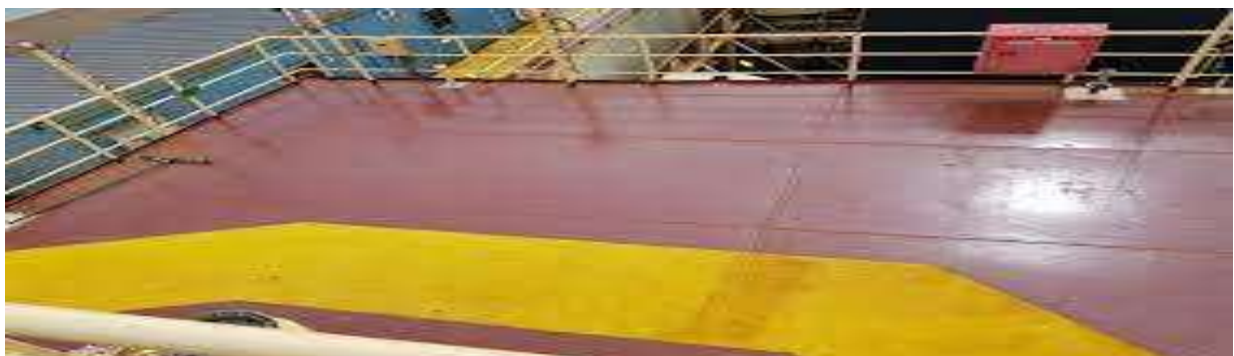
Figure (7): Repair of the corroded deck plate of the FSO Abu Cluster
(Source: McGeorge et al., 2009)

According to Paik and Thayamballi, (2007) if extensive areas of a floater require repair by welding, the floater must cease production, transit to a repair yard, undergo dry-docking for repair, transit back to the field and be recommissioned (Paik, 2022). Depending on the scope of work, availability of materials and resource persons, this might take several months. Although, the on-site welding repairs on small areas of a floater is usually achieved by waiting for calm weather condition and involves limited production shutdown, repair and then production restart (Andersen and Echtermeyer, 2006). However, even small repairs may take several weeks due to uncertainties in planning. A group of researchers agreed that the best way to minimise the need for expensive on-site repairs is by building in additional structural design safety margins at the outset of construction (Paik, 2022; Andresen, 2005; Hart-Smith, 1995). The authors explained that these margins must be as large as possible and much larger than those of shuttle tanker, given their five-yearly dry docking period (Park et al., 2020). It is usually adopted for deck plates repairs in non-hazardous areas like water ballast tanks. It was reported in Paillusseau et al., (2019) that an alternative to welding-based repair methods is to use adhesive patches (McGeorge et al., 2009). Notably, these are applied without hot work and thus present no fire hazard (Paillusseau et al., 2019). For example, composite fibre-reinforced plastic patches may be bonded (Paik, 2022) or laminated over structures to bridge and reinforce corroded or cracked areas (McGeorge et al., 2009). However, such adhesive patching may not restore the lost strength (McGeorge et al., 2009; Paik and Thayamballi, 2007), and imperfectly bonded parts may accumulate cargo and gas as the case might be. Interestingly, adhesive patches may prevent corrosion-associated leakage (Andresen, 2005). According to McGeorge et al., (2009) composite patch-based repair methods have been successfully applied to service naval ships, bridges and some infrastructures, and thus such methods should be considered for remediating damage on FPSO (Paik, 2022). Appendix AD shows the repair of the corroded deck plate of the FSO Abu Cluster. (Inset shows the deck plate before repair).

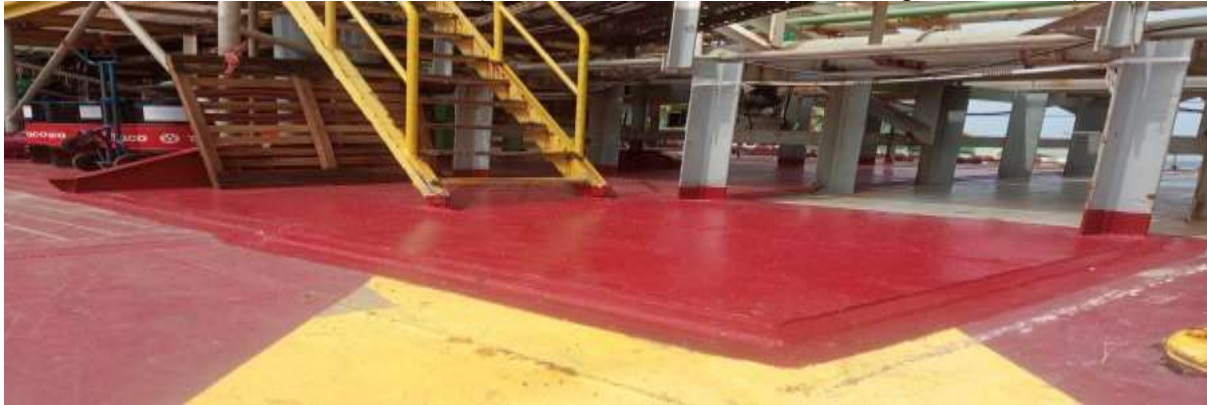
Figure (8): Composite repairs on FPSO main deck plate
(Source: MOG, 2023)
