Life Extension of Ageing FPSO and SPM Calm Buoy Mooring Chains Under Corrosion Effects - Part 2A

Citation: Ebunuoha C., Saturday E.G., Ebieto C.E. (2025) Life Extension of Ageing FPSO and SPM Calm Buoy Mooring Chains Under Corrosion Effects - Part 2A, *European Journal of Mechanical Engineering Research*, 12(2),30-52

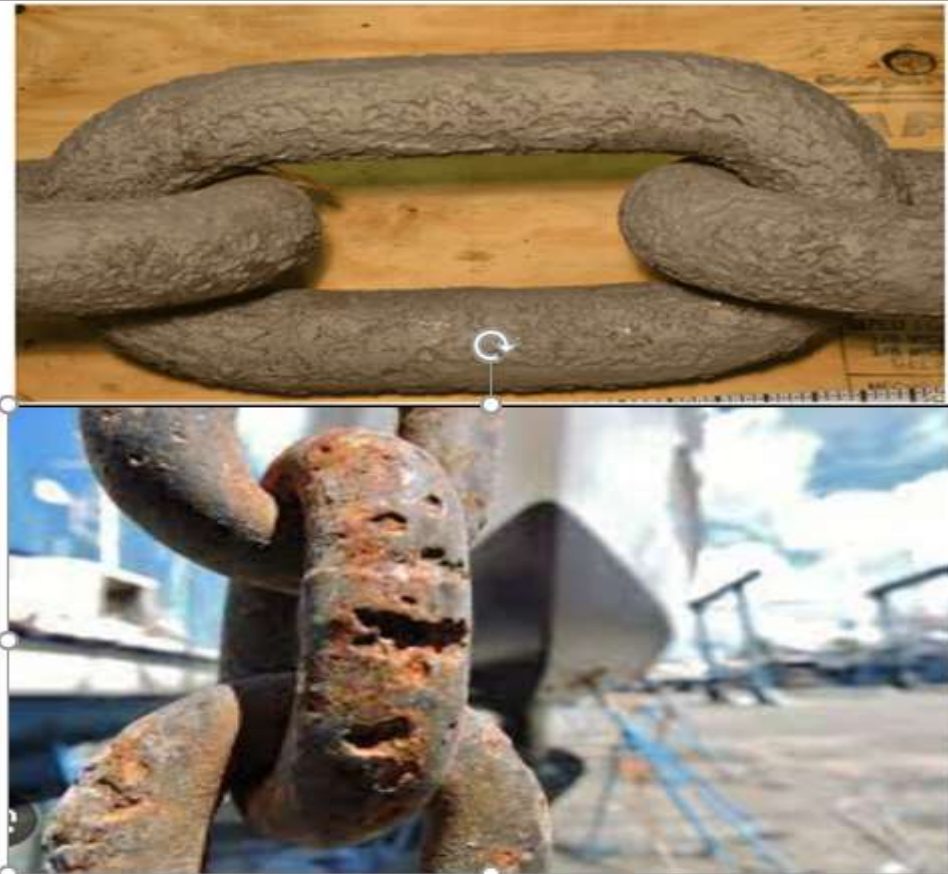
Figure (1): Pitting on mooring chains due to microbial induced corrosion [35]

However, the settling of microbiological cells depends on surface roughness. Cell adhesion to rough surfaces is generally higher. According to [45], rough surfaces typically offer increased surface area for the attachment of microbiological cells. When bacteria form biofilms on the surfaces of materials, this leads to corrosion. It's interesting to note that SRB can create hydrogen sulphide, which can damage metals, both in anaerobic and aerobic environments. As a result, the metal surface may be attacked by the metabolic wastage products of certain microbes. The very caustic biotic H_2S is produced by SRB metabolism. Carbon steel and biotic H_2S can react to form corrosion products [50]. On the other hand, aerobic bacteria refer to those group of microorganisms that requires oxygen to grow, thrive and multiply in an environment. Figure (1) shows pitting on mooring chains due to microbial induced corrosion.

The following factors influences the rate of pitting corrosion on mooring chains: pitting potential, metallic composition, temperature, PH and concentration of aggregate ions. Different types of bacteria are involved in a MIC process. The common bacteria types include:

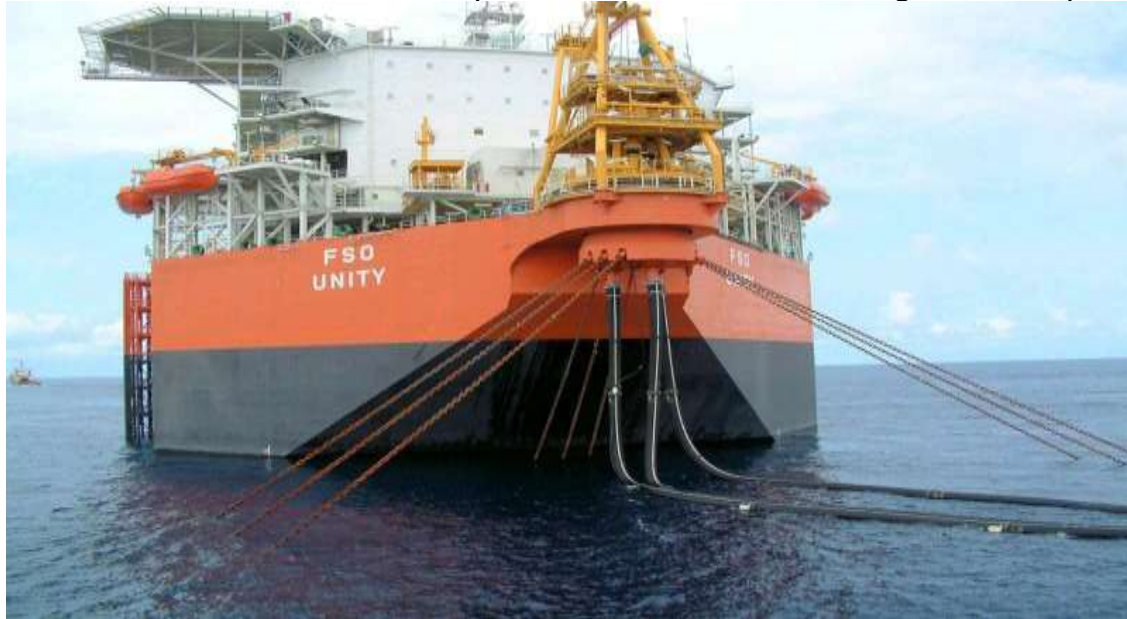
Figure (3): External turret mooring arrangement [18]

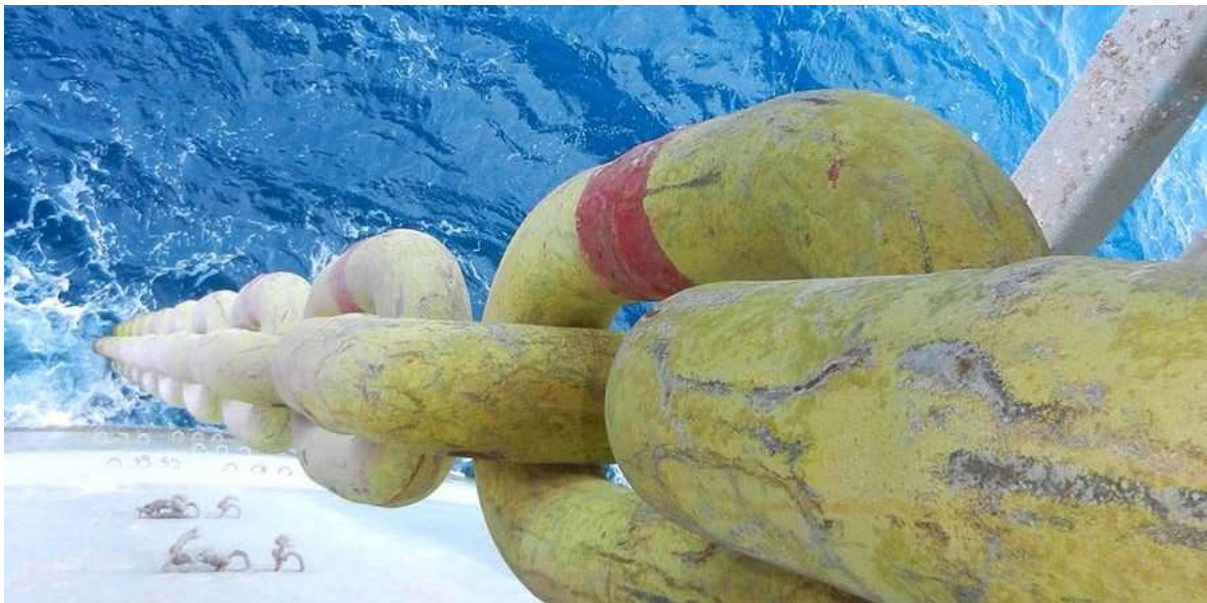
Figure (4): A Thermally sprayed aluminium coated mooring chains in operations [75]

The longevity of the mooring chain can be ensured by controlling the extensive attacks by MIC from the beginning through the use of appropriate protective coatings [43]. Applying epoxy or polyurethane coatings to the mooring chains is an excellent illustration [13]. Additionally, in certain offshore regions, particularly in West Africa, the application of TSA and TSC to mooring chains has resulted in a longer lifespan. Since 2001, mooring chains have employed the TSA, an aluminium-based coating, as a corrosion prevention strategy. However, it can be claimed that this coating has been field-tested in numerous mooring projects that have been in operation for more than 15 years. Additionally, evaluated were the coating's resistance to wear and its reaction to varying cathodic potential levels, both in controlled laboratory settings and in actual seawater situations. With a demonstrated endurance of over 25 years, the results demonstrated the advantages of applying TSA to offshore mooring chains by greatly increasing corrosion resistance. A thermally sprayed aluminium-coated mooring chain is depicted in Figure (4).

TSA coatings have been used extensively to prevent corrosion in marine environments on steel components, including FPSO/SPM mooring chains [34], [76]. However, because aluminium has a low wear resistance, TSA has been found to sustain significant damage during transport operations to the necessary site for mooring chain replacements [77], which causes a rapid coating degradation and deterioration when fitted. Furthermore, in some applications, such mooring chains or lines, wear between mooring connections or links causes the aluminium to deteriorate quickly under operating conditions. To ensure the longevity of the coating, it is advised that enhancing the sprayed layer's wear resistance be a top priority. However, TSA coatings have been extensively utilised to preserve submerged parts, including FPSO/SPM calm buoy mooring chains, which have an effective 30-year service life in various exposure locations. In conclusion, the following advantages come from applying thermally sprayed aluminium for mooring chain coatings:

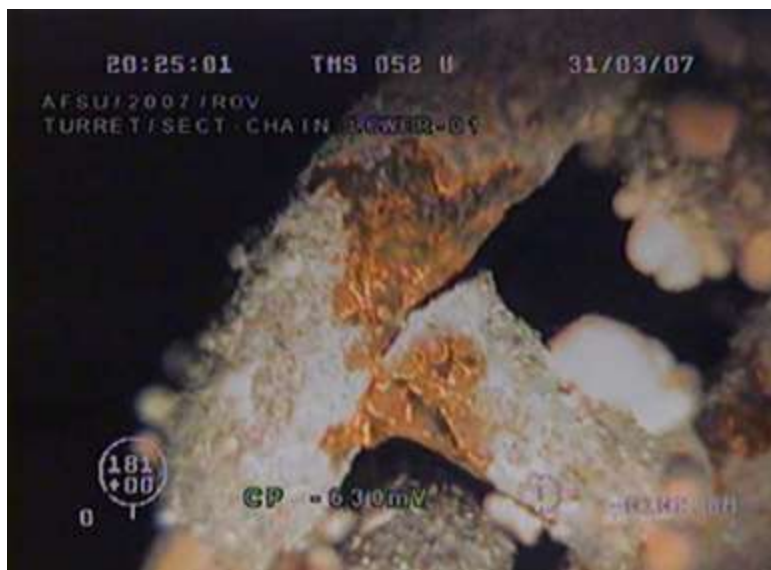
Figure (7): Partially loosed stud [56]

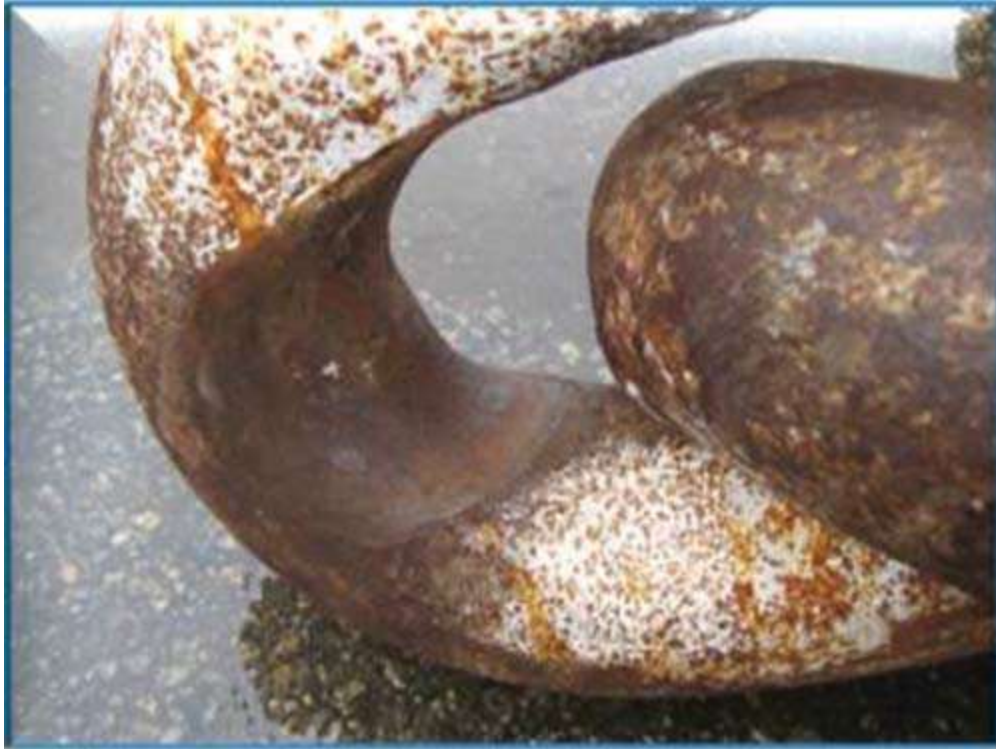
Plate (8): Wear and tear on chain link [91]
