Life Extension of Ageing FPSO and SPM Calm Buoy Mooring Chains Under Corrosion Effects - Part 2B.

Citation: Ebunuoha C., Saturday E.G., Ebieto C.E. (2025) Life Extension of Ageing FPSO and SPM Calm Buoy Mooring Chains Under Corrosion Effects - Part 2B, *European Journal of Mechanical Engineering Research*, 12(2),1-29

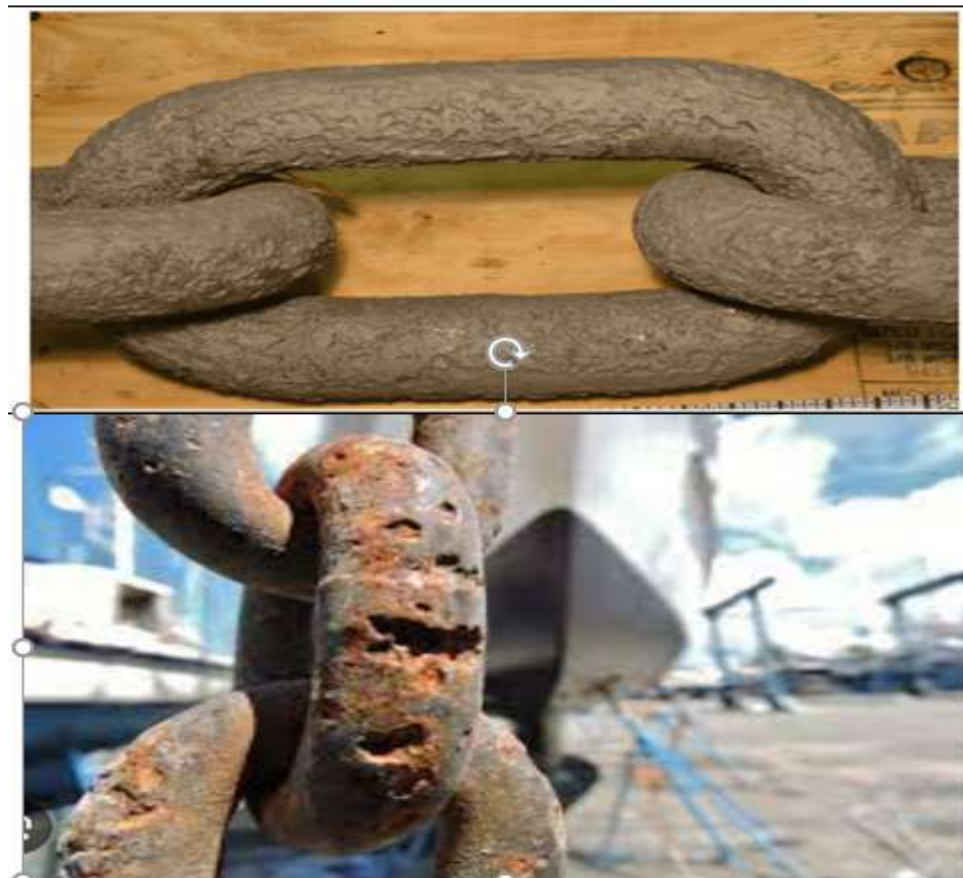
Figure (1): Pitting on mooring chains due to microbial induced corrosion
(Source: Melchers, 2003)

Publication of the European Centre for Research Training and Development-UK which can corrode metals. Thus, the metabolic by-products from some microorganisms can attack the metal surface. SRB metabolism produces biotic H_2S , which is a highly corrosive substance. Biotic H_2S can react with carbon steel to produce corrosion products (Venzlaff et al., 2013). On the other hand, aerobic bacteria refer to those group of microorganisms that requires oxygen to grow, thrive and multiply in an environment. Figure (1) shows pitting on mooring chains due to microbial induced corrosion.

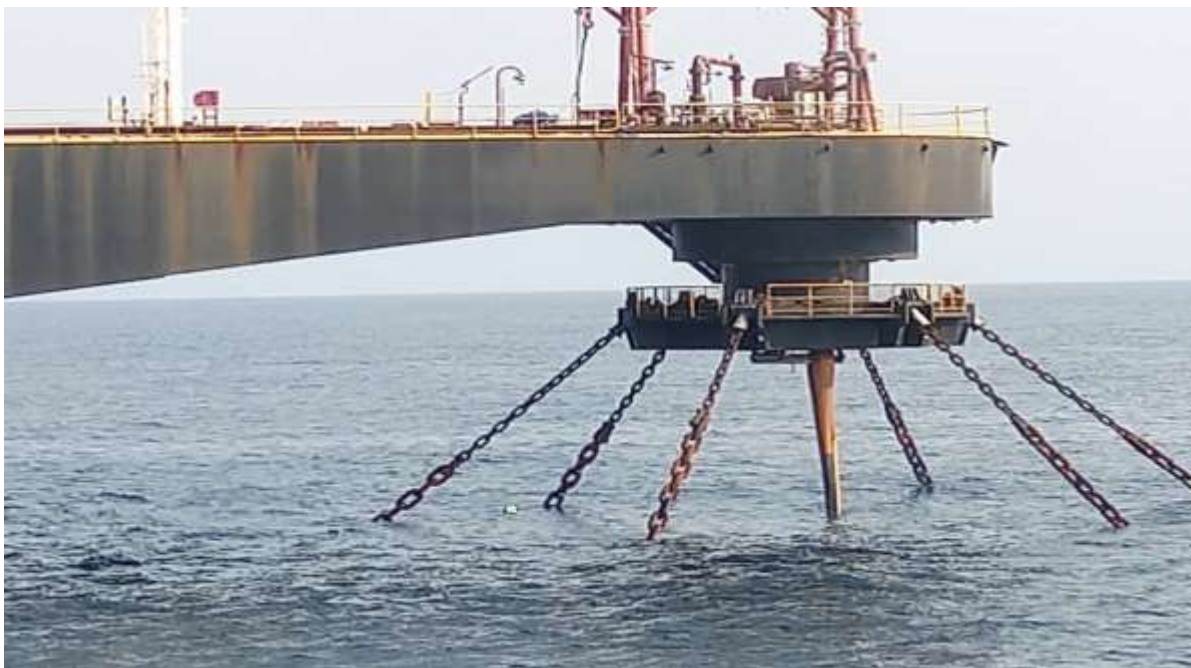
Figure (3): External turret mooring arrangement (Source: Maslin., 2013)

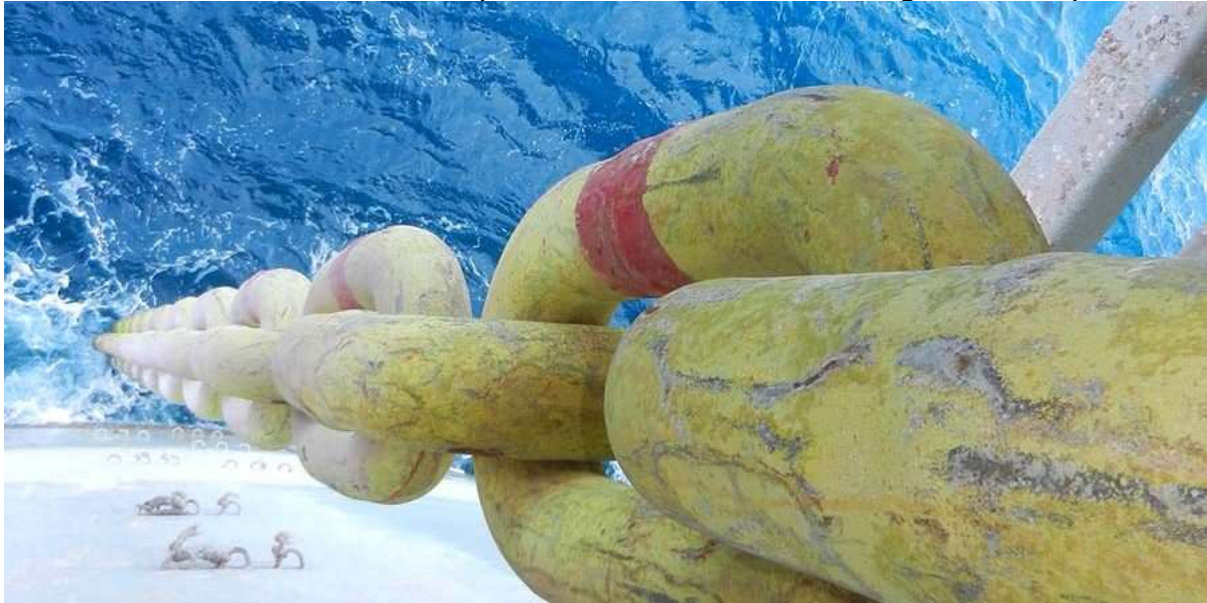
Figure (4): A Thermally sprayed aluminium coated mooring chains in operations
(Source: Ma et al., 2019)

The TSA, which is aluminium-based coating, has been used as corrosion protection measure in mooring chains since 2001. Although, it can be said that this coating is field-proven in many mooring projects with more than 15 years in service. The capability of the coating to resist wear and its response under different cathodic potential levels were assessed as well, both in the laboratory, under controlled conditions, and in the sea water real environments. Results showed that the benefits of applying TSA to offshore mooring chains by significantly enhancing corrosion resistance with a proven durability of more than 25 years. Figure (4) shows a thermally sprayed aluminium coated mooring chains.

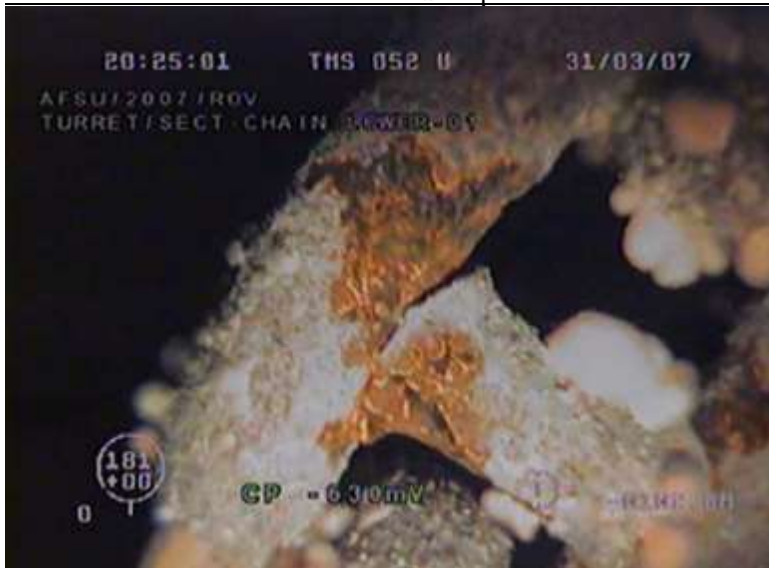
Figure (7): Partially loosened stud
(Sharp and Ersdal, 2021)

Most of the events that triggers mooring chains failures are: corrosion, fatigue, installation, manufacturing defects, mechanical, IPB, OPB and design. For instance, the mooring chains installed in offshore West Africa were selected based on the corrosion rates in North Sea, whereas the offshore West Africa has recently been identified as a temperate region with sea water surface temperature rising up to 30.4°C in some oilfields. Some researchers reported up to 28 °C in the past, while in some locations you have 26.9 °C. Figure (5) presents the causes of failure and pre-emptive events for chain. Figure (6) shows load regimes for a stud link showing failure regions. Figure (7) represents a partially loosed stud. Figure (8) represents wear and tear on chain link.

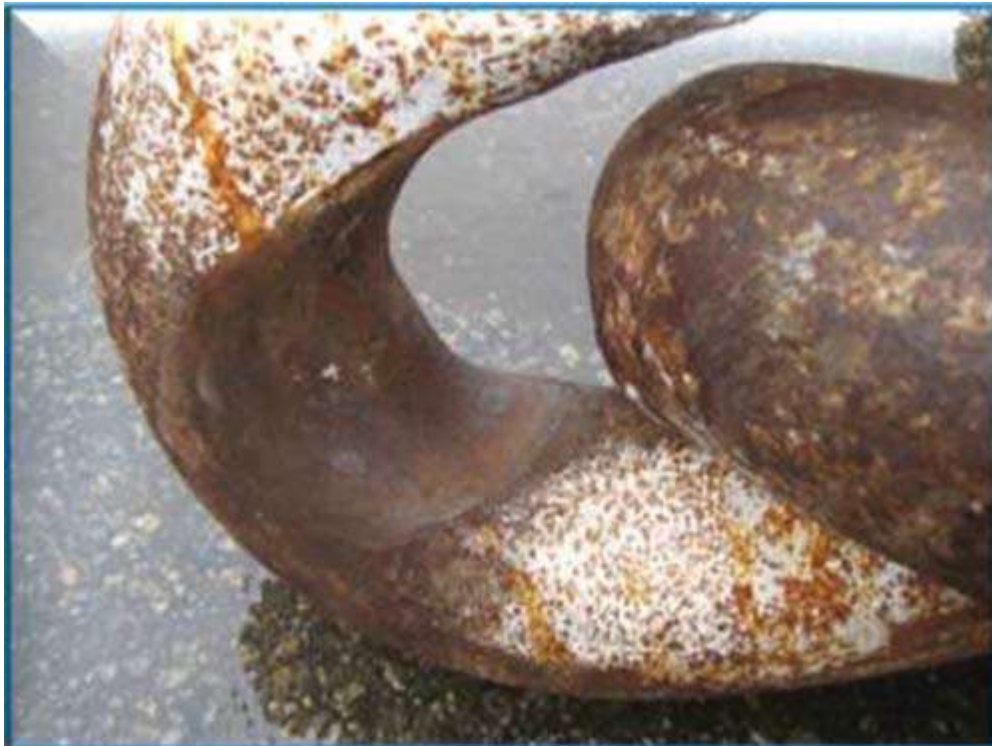
Figure (8): Wear and tear on chain link
(Source: Birades and Verney, 2018; HSE, 2017)
